TIPS FOR PREVENTING EXPENSIVE WARRANTY CLAIMS

National Home Warranty would like to bring the following issues to your attention with the intention of assisting you in avoiding costly claims. As you are aware, water ingress through a building envelope is a 5-year warrantable item. Keeping that in mind, we have detailed a number of envelope and other construction errors that we have witnessed during inspections and would like to bring them to your attention.

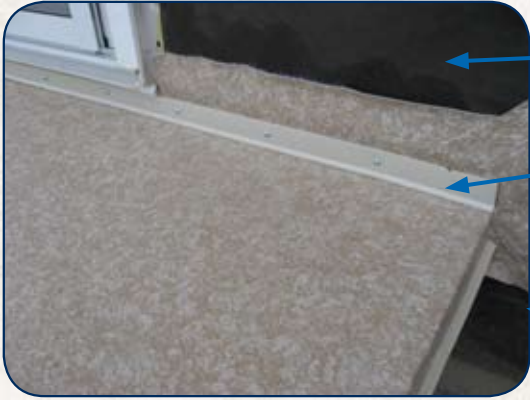
Building paper should overlap the deck membrane.

The metal strip placed into deck to wall connections is unnecessary and the screws puncture the vinyl membrane allowing a potential leak every few inches.

Good deck side to wall connection.

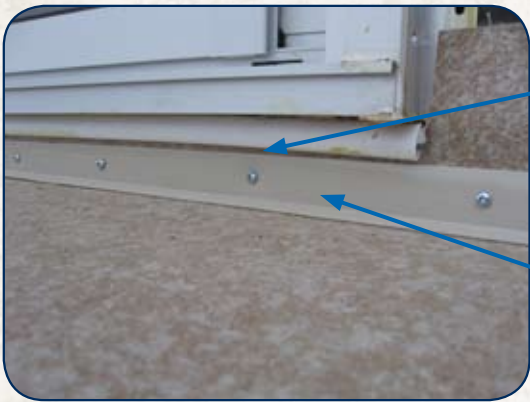
The vinyl membrane should wrap up and into the rough opening of the door sill. The door sill then sealed to the membrane. As decks are now roofs under the BC Building Code therefore the vinyl membrane should run up the wall a minimum of 6" behind the cladding and under the wall paper. The door sill should be 6" above finished deck / patio heights. This requires lowering the deck or raising the door. We allow a relaxation of this to 3" - 4" for roofed over decks and entrances. A 2' overhang is not considered roofed over.

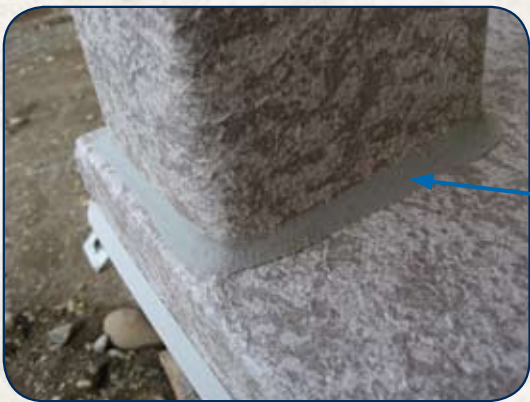
Vinyl membrane connections should be welded and not just a caulked connection.

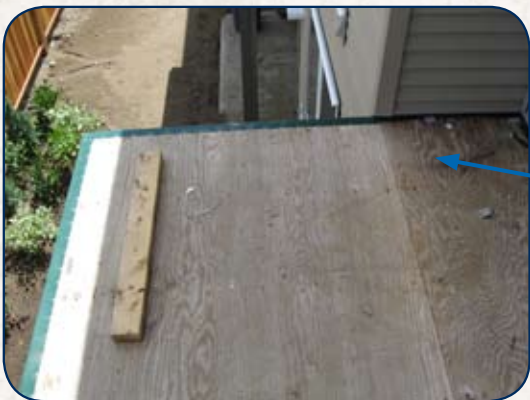
Deck membranes must be completed before paper and siding are applied to allow membranes to go up under the cladding. Also required to ensure correct deck side to wall connection details.

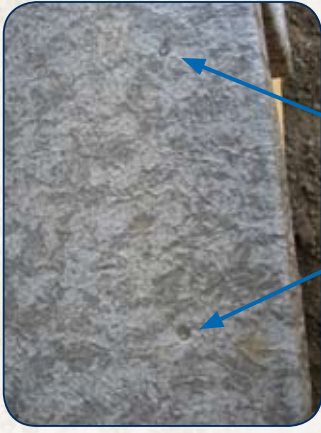
Nails penetrating deck membrane are unacceptable and must be repaired.

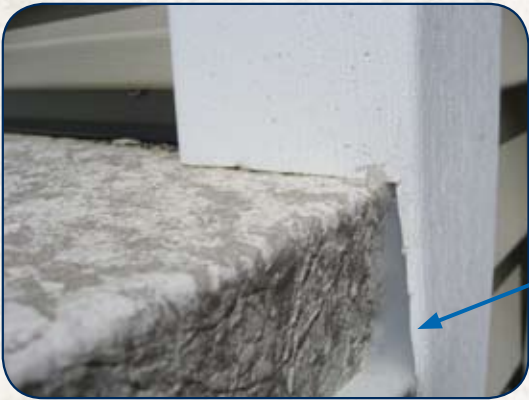
Deck edge to wall connections to be applied as per details proved in our drawings on our website under "Rainscreen details". Caulked connections such as this are not acceptable.

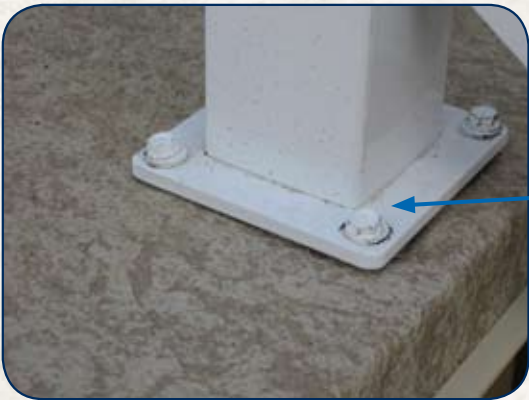
Deck railings that are top mounted with screws through the deck membrane will fail over time requiring replacement of decking and membrane. Recommend side mounted railings. Mandatory on multi-family projects.

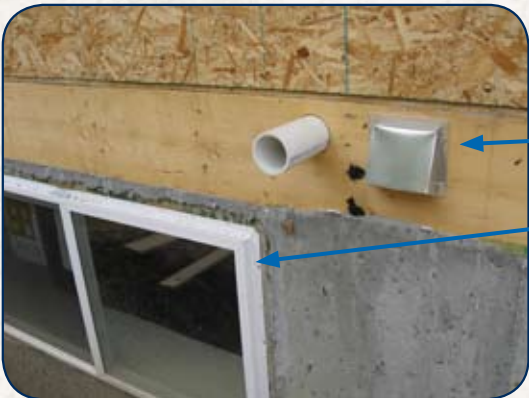
All penetrations need to be sealed with peel & stick or EPDM membranes and correctly lapped into the papering layers. Includes all ducts, electrical boxes, pipes and wires, windows, and doors.

Window should have been installed on starter paper and a peel and stick sill. (See our drawings for details).

Caulk all vertical cladding edges to concrete.

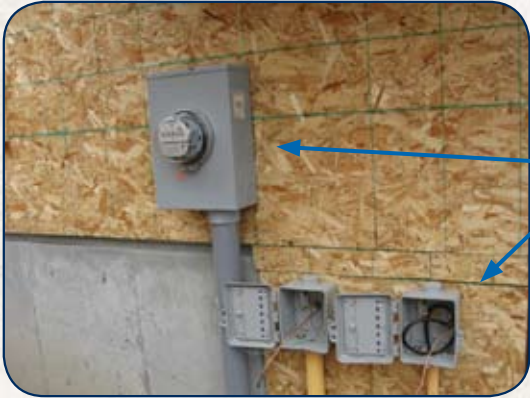
Peel and stick and or EPDM membrane, and paper should be applied behind and around power boxes and conduits to ensure continuous lapping and layering of paper and a water tight seal.

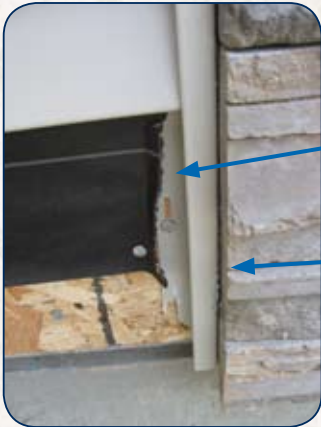
Paper should be continuous behind j-bead, stonework, and deck below.

Joint between vertical j-bead and stonework should be caulked to prevent water egress.

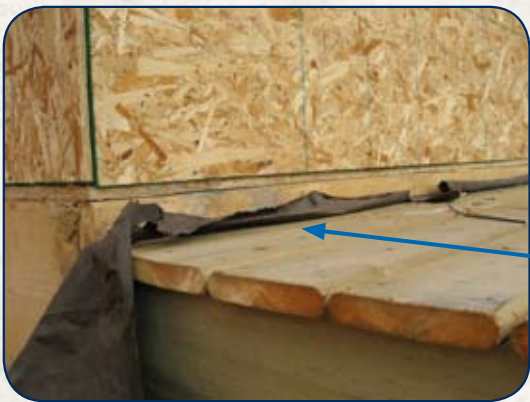
Paper should be continuous behind decking headers and lap over the wall paper below the deck, when a planked drip deck is installed.

This paper should be protected by a wide band of metal flashing that laps over the wall cladding below the deck.

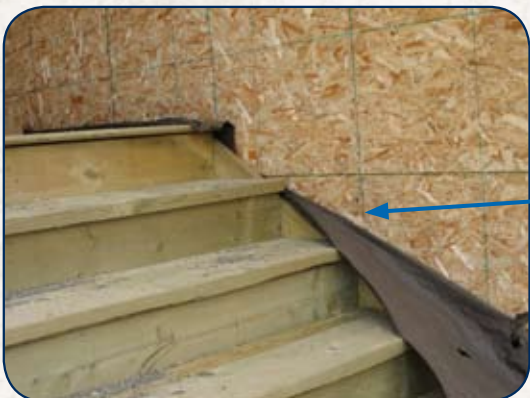
Similar to deck photo above, the paper should be continuous behind the stair stringers and protected by a wide band of metal flashing that laps over the paper and cladding below the stringers.

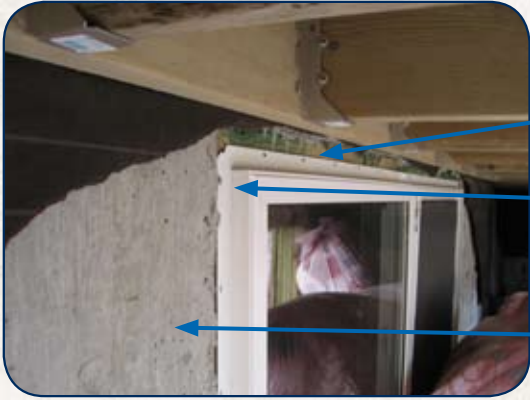
The paper should continue under the deck, be protected with metal flashing, and overlap the paper and cladding that should be installed around this window.

Window should have been installed on starter paper and a peel and stick sill. (See our drawings for details).

Window must be finished with proper cladding or trim. The vertical sides of the trim to be caulked to the concrete.

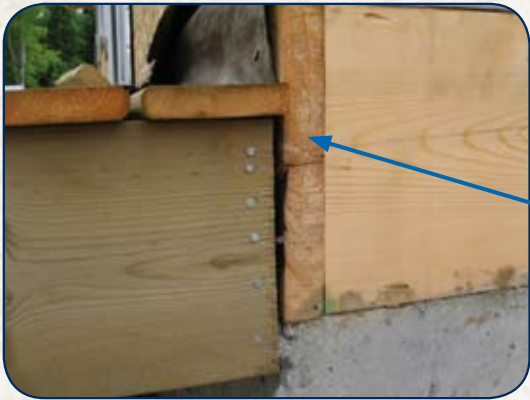
The connection of this deck and the corner of the building need complete reworking to prevent water from penetrating the wall cavity.

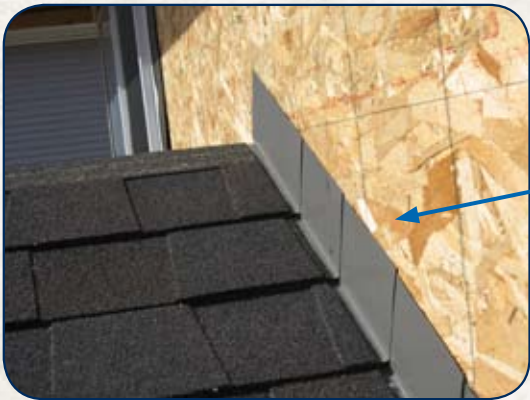
The roof flashing on this home should have starter paper under it. Metal flashing should not be on bare wood.

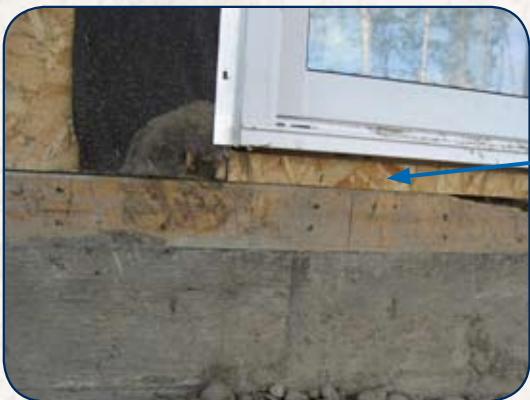
Sliding door should have been installed on starter paper and a peel and stick sill. (See our drawings for details).

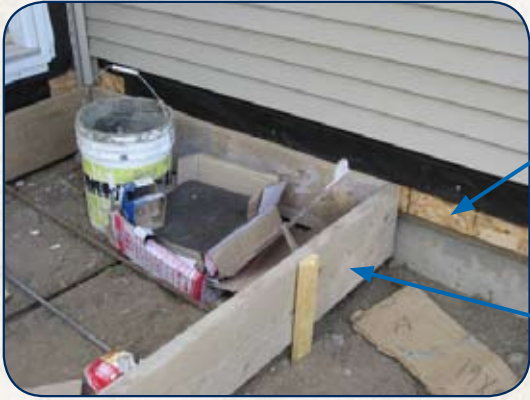
Paper should extend to below wood framing.

This proposed concrete pad should not be against bare wood. As proposed the stripping of the form work that abuts the wall may damage the siding.

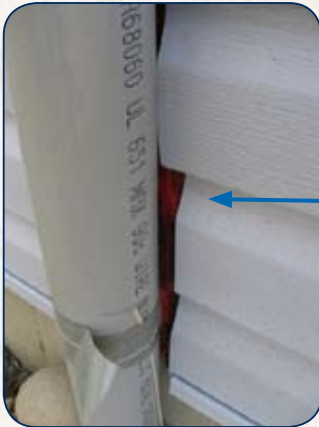
The vinyl siding should be continuous behind this conduit or box cladding out and around the conduit.

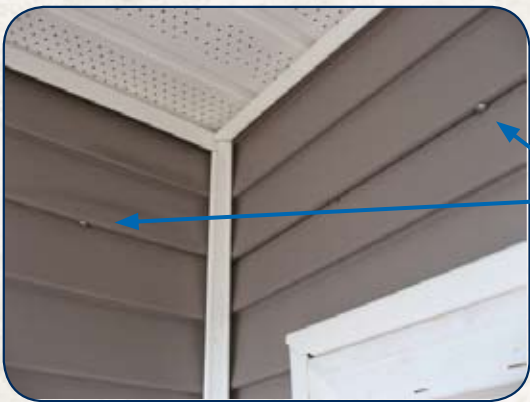
The use of screws through the vinyl siding is not to manufacturer's installation specifications. Use a snap lock punch to lock in the last row of vinyl siding.

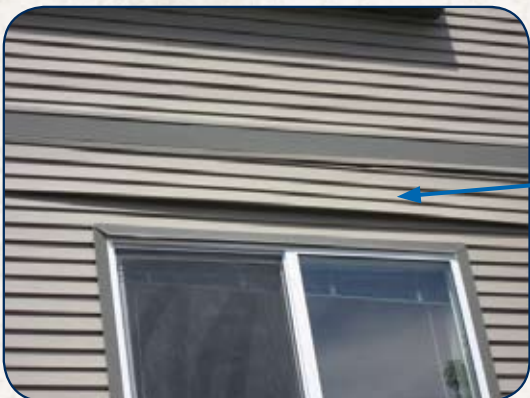
Due to incorrect installation this top row of siding is falling off. Use a snap lock punch to lock in the last row of vinyl siding.

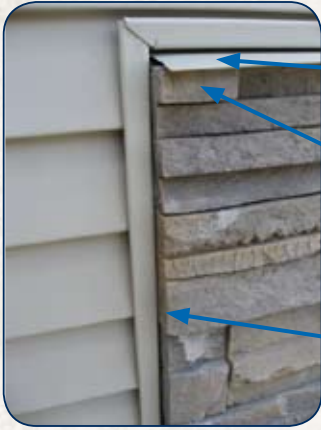
This flashing should have an end dam on it. The flashing should also have a vertical leg dropping a minimum of 10mm down over the front of the cladding below it (the stone).

If the stone facing had a 6% or more sloped stone sill, then the sloped flashing could run onto that and would not be required to hang down over the front of the stone.

The vertical joint between the vinyl siding and stone needs caulking.

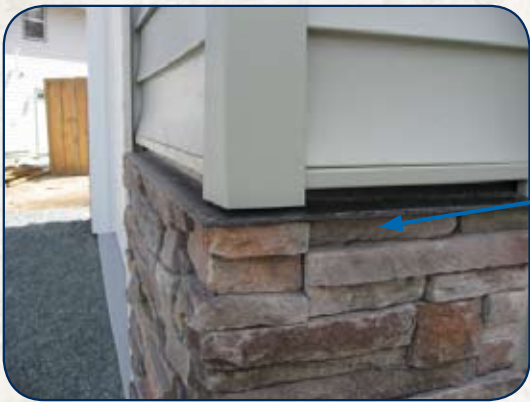
This flashing requires a minimum slope of 6% and because there is no sloped stone sill the flashing must have a vertical leg hanging down over the stone a minimum of 10mm.

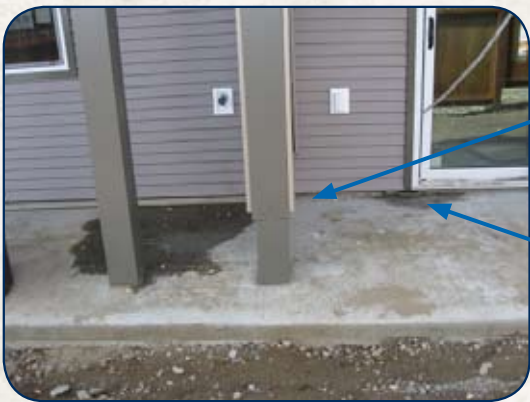
Using a starter strip or a perforated j-bead is required at the bottom of a vinyl wall.

Here a non-perforated j-bead causes water leaking from a hose bib to carry horizontally to the right and put water into a door sill opening.

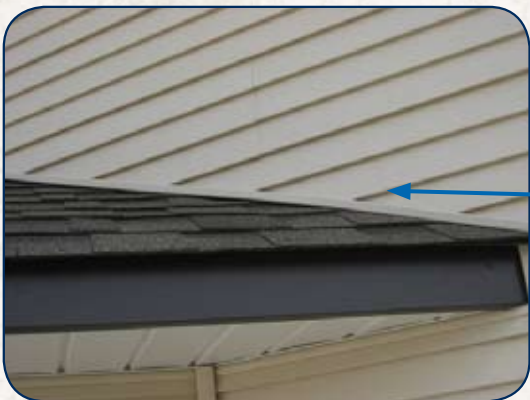
Vinyl siding must be kept 2" from the finished roofing.

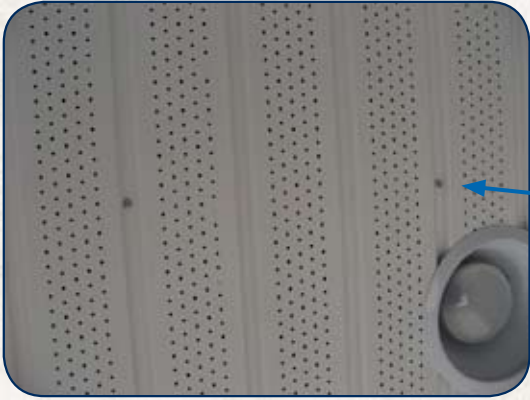
Fastening screws for soffitting should not be visible.

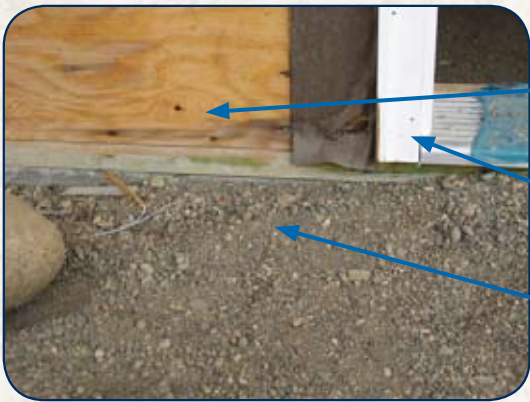
Wood framing should be minimum 8" above finished grade.

This door's rough opening needs correct detailing to prevent water penetration. (See our drawings for details).

The grade level here requires lowering.

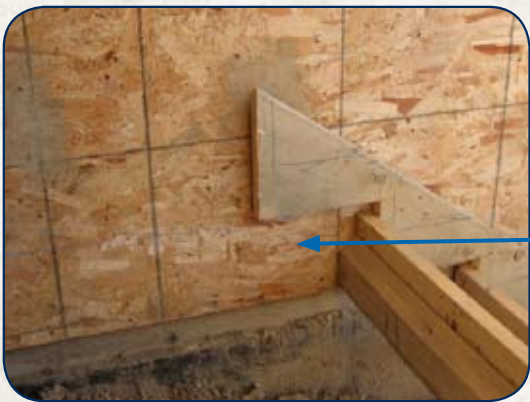
This proposed concrete staircase cannot be poured against bare wood. Paper, peel & stick waterproof membrane and metal flashing, correctly lapped into paper and cladding above and below are required.

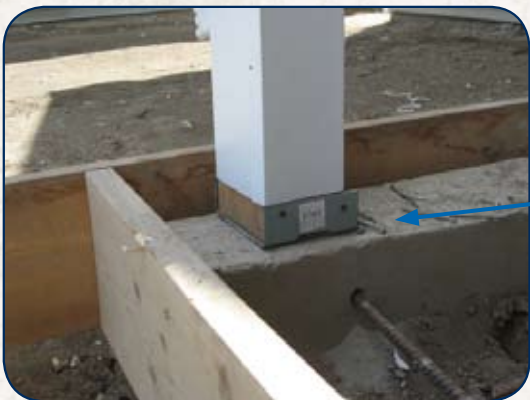
This post cannot be buried in concrete as proposed.

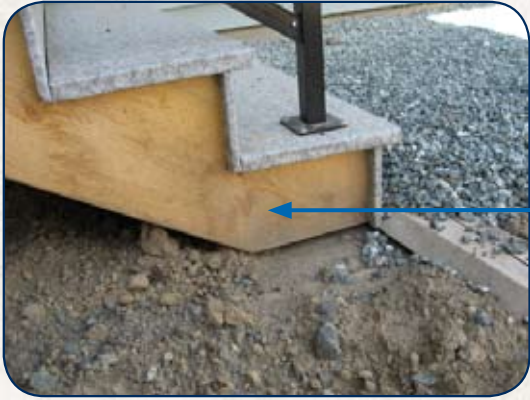
Wood that is within 8" of the ground must be treated.
This wood is not.

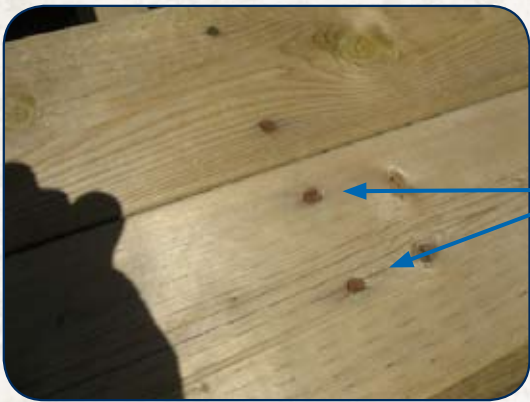
Only fasteners rated for use with ACQ lumber can be used with ACQ lumber. These nails are already rusted and the home is not finished yet.

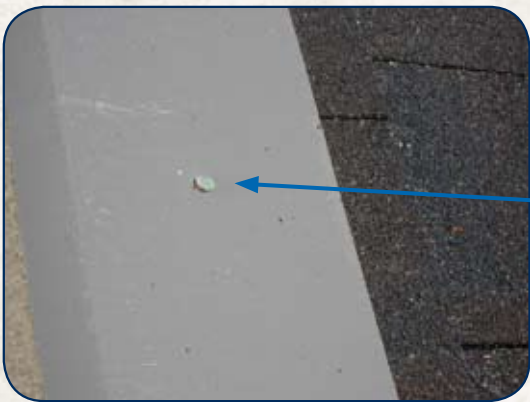
All roof cap flashing nails need to be sealed with caulking.

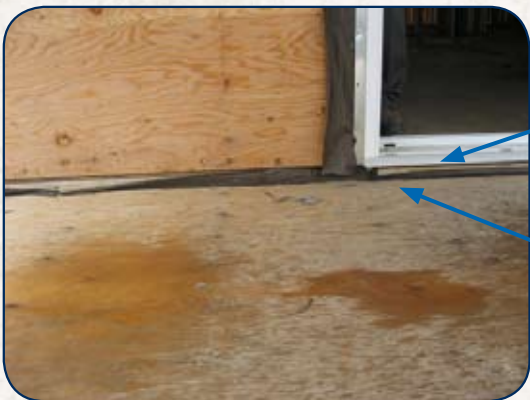
This patio door is too low to the deck.

The door needs removing to allow the deck membrane to be correctly detailed around the opening.

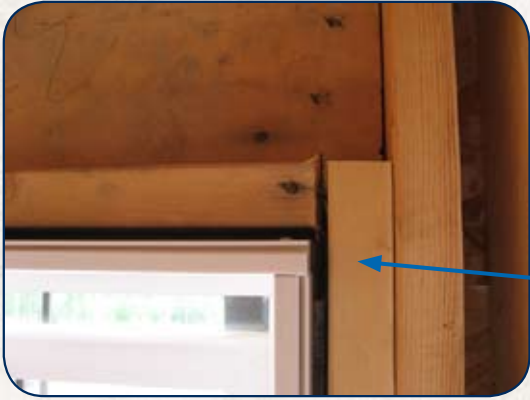
Windows need to be sealed to continue air barrier. Use rod and caulk to seal window frame to wood framing / paper that is wrapped around into the rough opening.

Caulk around entire perimeter of inside of window including across the bottom to provide a back dam for the peel and stick wrapped on the rough opening sill.

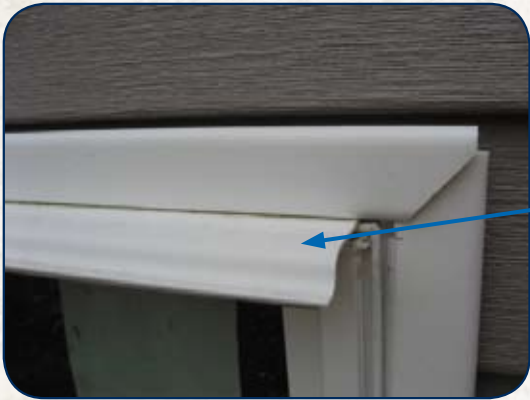
This window flashing does not meet code. Install correct window flashings. Flashing requires an end dam and a 10mm vertical leg offset 5mm from the window. (See our drawings for details or the BC Building Code 2006.)

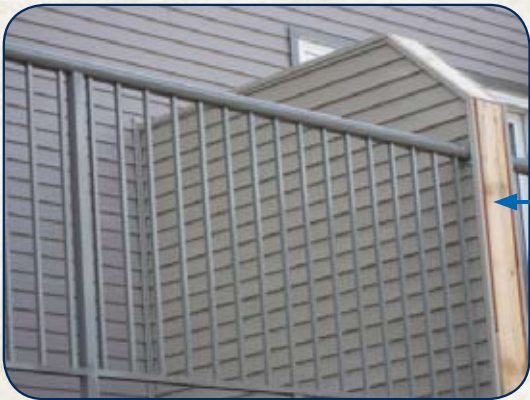
Parapet walls needs correct detailing to prevent water egress. This wall needs reworking.

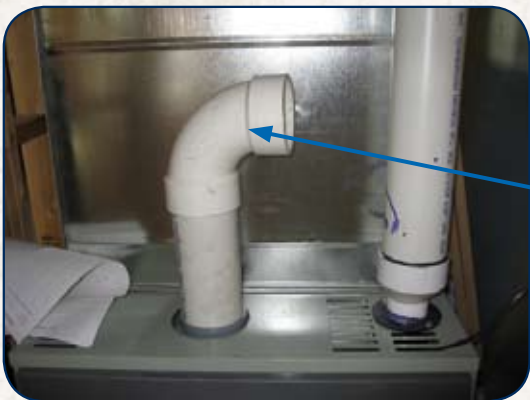
To ensure high efficiency furnaces operate to their full potential run intake air ducts directly from the home's exterior and not the utility room.
